Effect of Heat Treatment on Hardness and Microstructures of AISI 1045

Abstract. The SAE/ AISI 1045, a type of medium carbon steel, is used most commonly in various structural and element of machines. Sometime, it failed during the in-service, which assumed to be caused by cracking in material as the effect of casting, manufacturing, or heat treatment processes. The current research was developed to find out the effect of hardening and of tempering processes toward hardness, microstructure and cracking. The objectives of the current research are to obtain the effect of cooling rates toward the hardness and cracking and to define a proper cooling media to get a martensite microstructure without cracking of heat resistant products. Results showed that the chemical composition from the spectrometry test confirmed that the specimens were classified as AISI 1045 or JIS S45C. The hardness values properties increased with increase of temperature, except at 1000 °C. The specimens having the hardness property more than that of ASME II standard were not useable due to its brittle.

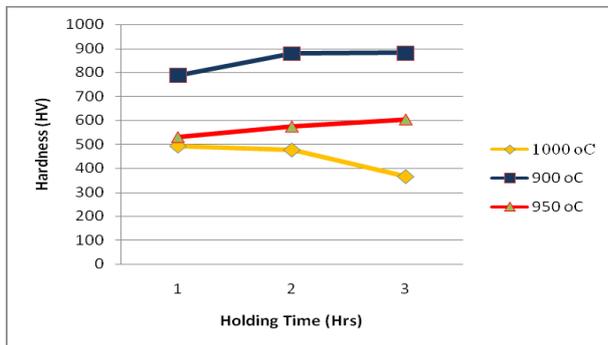
Fig. 1. Holding time vs hardness with different of temperature

Hardness Testing. The result of the initial specimens, before heat treatment, was on average of 290 HV. After the heat treatment with various temperatures and time control, the results showed in Figure 1 and Figure 2.

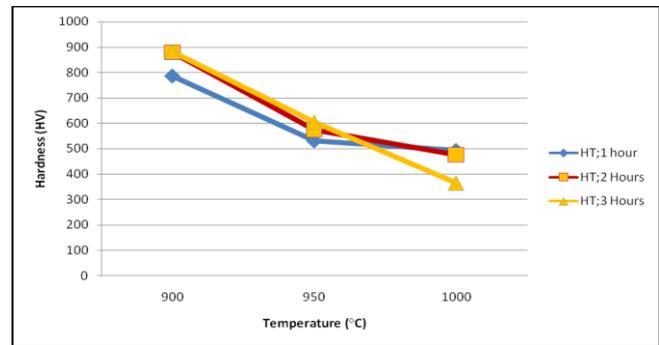
Fig. 2. Temperature vs hardness with different of holding time

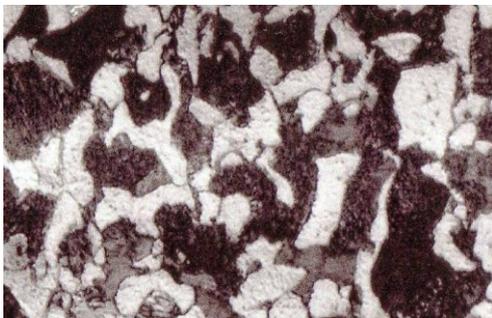
Fig. 3. The microstructure before hardening heat treatment. The ferrite (bright) and the pearlite (dark). 400x, 2%Nital

Metallography Examination. The metallography examination and the analysis were based on Vander Voorf procedure [8]. The steps were started from specimens cutting to grinding and polishing, etching the surface using the Nital's reagent etchant, and generating the microstructure sample under an optic microscope. The examination results obtained from the micrographs with 400X magnifications and 2% Nital's reagent etchant (Figure 3–9). An AISI 1045 sample before heat treatment consists of ferrite and pearlite structures (Fig.3), and the same material samples were heat treated on its surface by hardening at 950°C and 1000°C with holding time of 180 minutes, 120 minutes, and 60 minutes respectively which obtained the martensite structures. Unfortunately, on all surface structures (Figure 4 – 9), appeared quench cracking. It means the higher heating temperature, the higher quench cracking, but also the higher holding time, the higher quench cracking.

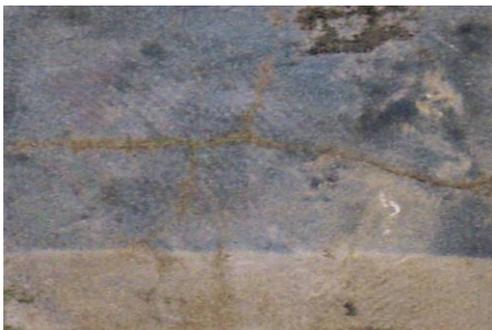
Fig. 5. The surface structure after hardening at 950°C, holding time of 60 minutes. The crack appear due to cracking quenched. 400X, 2%Nital

The higher martensite hardness due to AISI 1045 will be brittle, and during rapid cooling until room temperature, it shall attend the residual stress. If tensile residual stress was higher than the tensile strength, so this material occurred the quench cracking. If these samples examined by The Scanning Electron Microscope with magnification up to 5000X, it may be revealed intergranular fracture. Therefore, quench cracking was very sensitive to external loading, so it must be decreased the carbon content or decarburizing by using tempering process. Decarburization microstructure after tempering produced as shown in Fig. 10–12 that on the top of pictures were a part of sample surfaces. On surface of sample can be measured the layer thickness of decarburization as tempering product. Carbon trapped during phase transformed from austenite to martensite, and it can be released by heating on AISI 1045 at A_1 line below of $Fe_3C - C$ phase diagram. Releasing carbons, surface structure deformed plastically and releasing the residual stress. Its reason that decreasing hardness and increasing the toughness on material. The measuring results that the carburization layer thickness after tempering process of AISI 1045 at 900°C, 950°C and 1000°C obtained the 304 μ , 350 μ and 418 μ respectively.

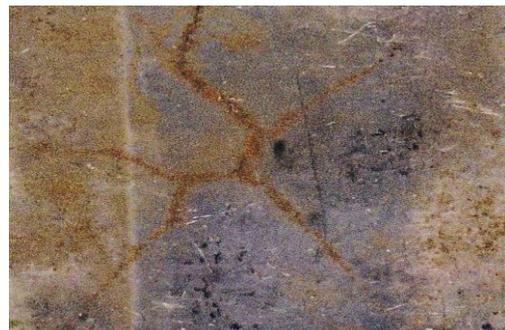
Fig. 6. The surface structure after hardening at 950°C, holding time of 120 minutes. The crack appear due to cracking quenched. 400X, 2%Nital

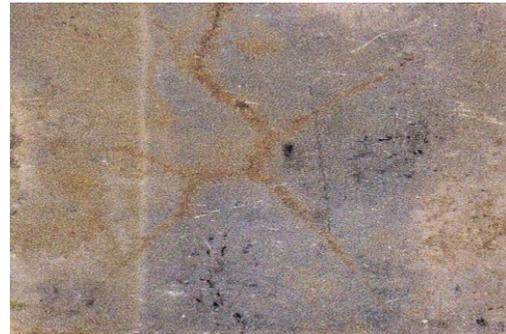
Fig. 8. The surface structure after hardening at 1000°C, holding time of 60 minutes. The crack appear due to cracking quenched. 400X, 2%Nital

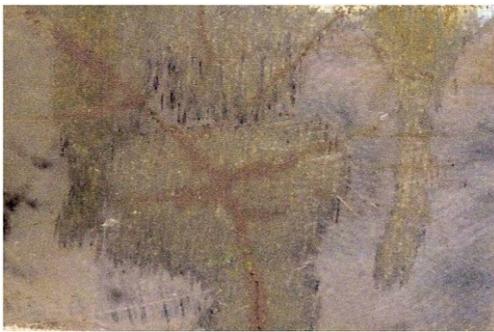
Fig. 9. The surface structure after hardening at 1000°C, holding time of 120 minutes. The crack appear due to cracking quenched
